CALSPAN ON-SITE AIR BAG DEPLOYMENT INVESTIGATION

CALSPAN CASE NO. 90-14

FLEET - 1990 DODGE DYNASTY

ACCIDENT DATE - [REDACTED] 1990

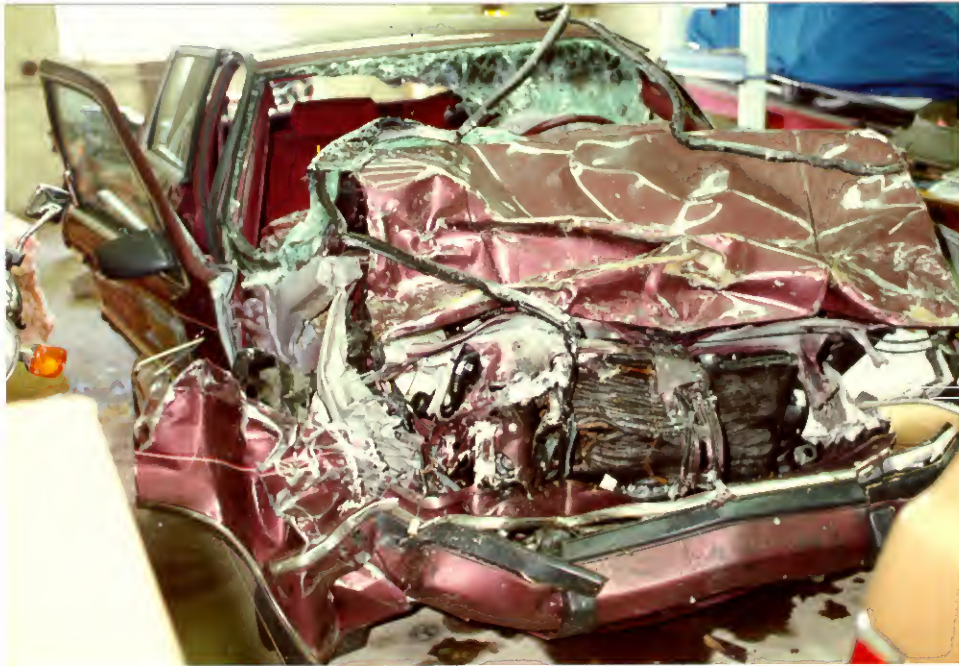
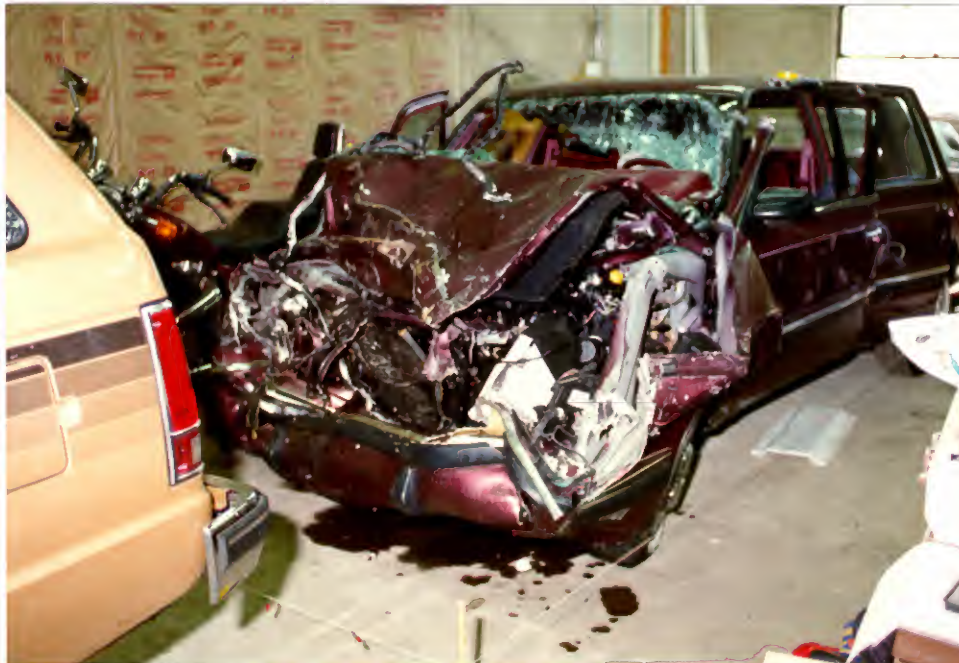
## VEHICLE DAMAGE

Frontal Views Of The Dodge Dynasty

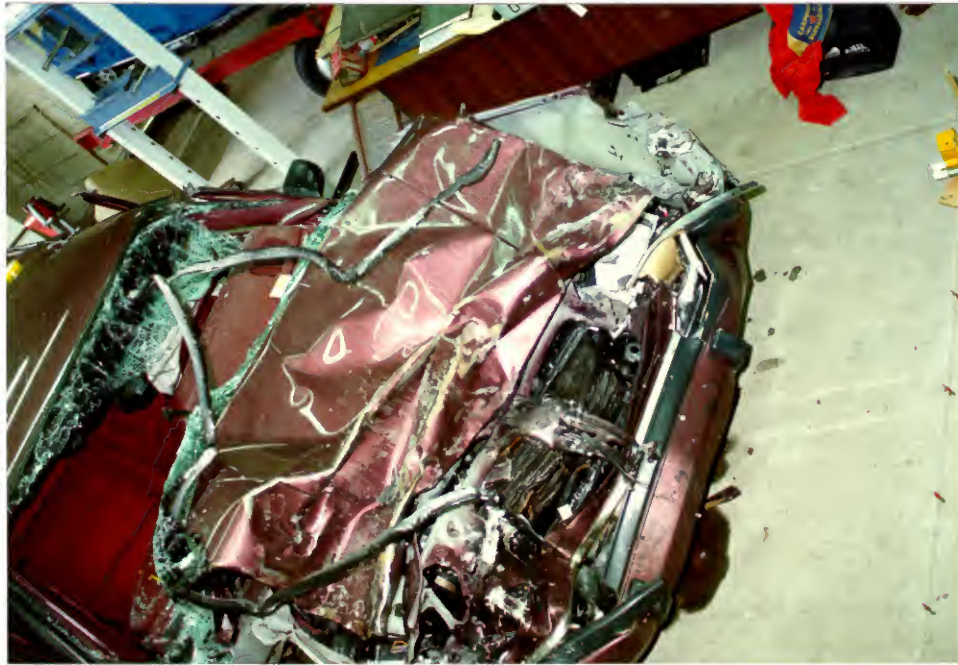
Overhead View Showing The Extent Of Crush

Impact speeds and delta Vs were computed by the damage and trajectory algorithm of the CRASHPC program.

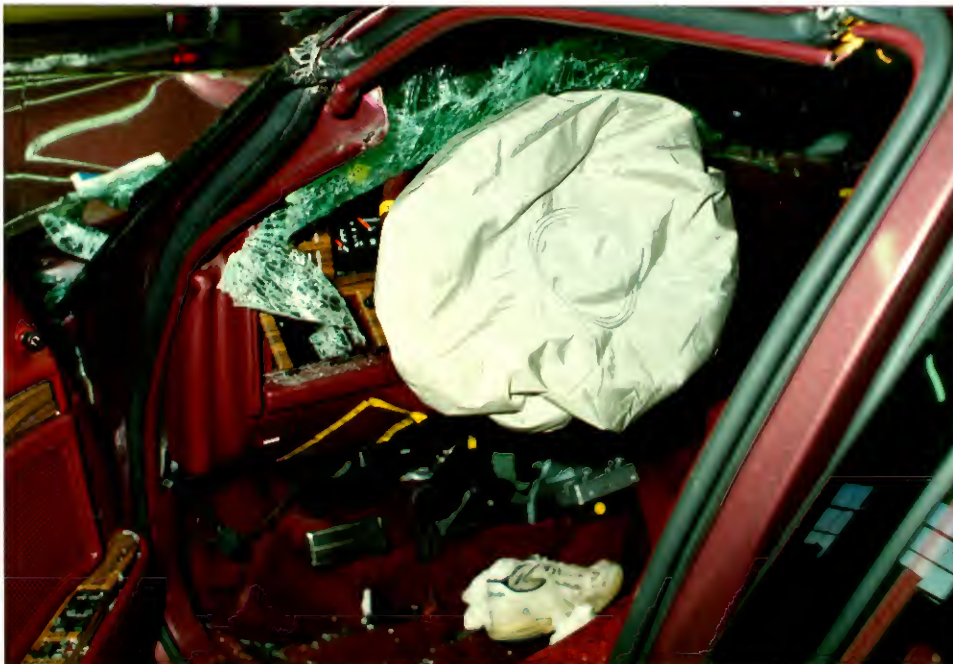
Overall View Of The Deployed Air Bag And Driver Knee Contacts

The driver's right knee loaded the intruding knee bolster 9 - 12.5" left of center. The contact resulted in an open, grossly comminuted, fragmented fracture of the right patella. Bone fragments from the patella penetrated the rigid exterior face of the bolster and continued through the styrofoam backer. Bone also penetrated into the subpanel that reinforced the bolster assembly. The energy from the bolster contact was transmitted into his right femur which resulted in multiple displaced fractures of the femur and a fractured right acetabulum. His left knee scuffed the bolster 19.5 - 24.5" left of center, however no injury occurred.

The 1990 Dodge Dynasty was equipped with a supplemental driver air bag system that deployed as a result of the head-on impact sequence. The air bag was tethered and measured approximately 23" in diameter (deflated). The air bag was vented by two ports located on the module side of the bag (away from driver) at the 3 and 9 o'clock positions. There was no generant residue in the area of the venting ports. The air bag was intact with no damage to the bag material.

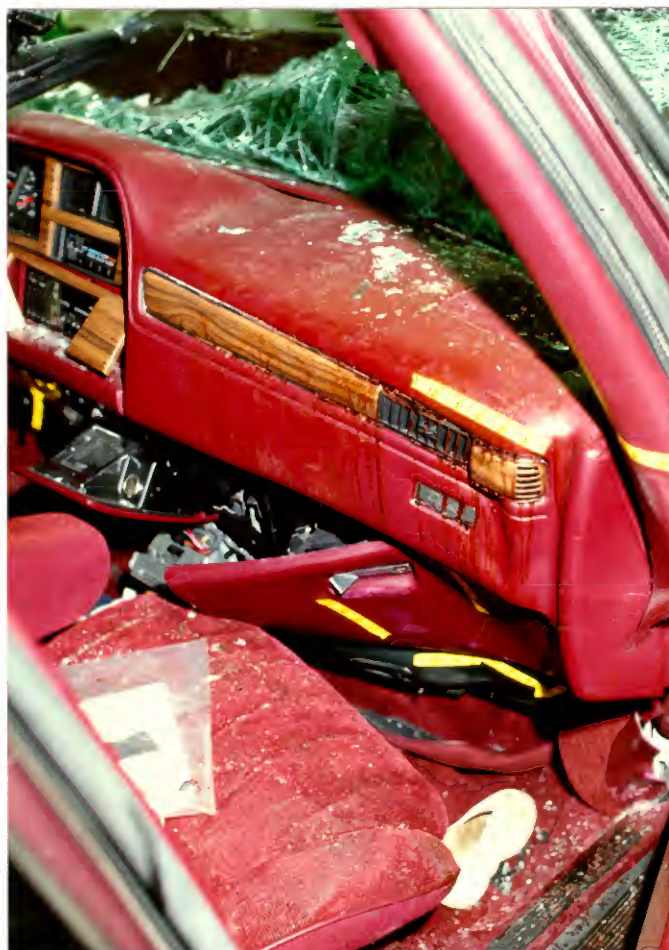
Right Front Passenger Contact Points

The right front passenger of the Dodge Dynasty was not wearing the active 3-point lap and shoulder belt system. At impact she moved forward and slightly to the right with respect to the vehicle as the vehicle rotated in a counterclockwise direction. Her knees loaded the intruding glove box door which scuffed the door and deformed it to a depth of 4". The passenger's left foot scuffed the intruding heater duct 8 - 15" left of center. Her upper thoracic area impacted the right side of the upper and mid instrument panel area, deforming the padded panel 0.75" in depth over a 6.5" diameter area that involved the air conditioning vent. The passenger's facial area impacted the upper A-pillar and the right side of the windshield. A scuff mark evidenced the pillar contact and tissue and hair deposits were noted to the cracked windshield 2.5 - 4" inboard of the A-pillar. As a result of the facial contacts, the passenger sustained a contusion of the right forehead, multiple abrasions and lacerations of the face, and a basilar skull fracture with a closed head injury. Although her medical records were not available, she reportedly sustained prolonged loss of consciousness and was unresponsive to pain stimuli. The right front passenger came to rest slumped against the instrument panel. She was transported by helicopter to a major medical center where she was admitted for treatment of her injuries.

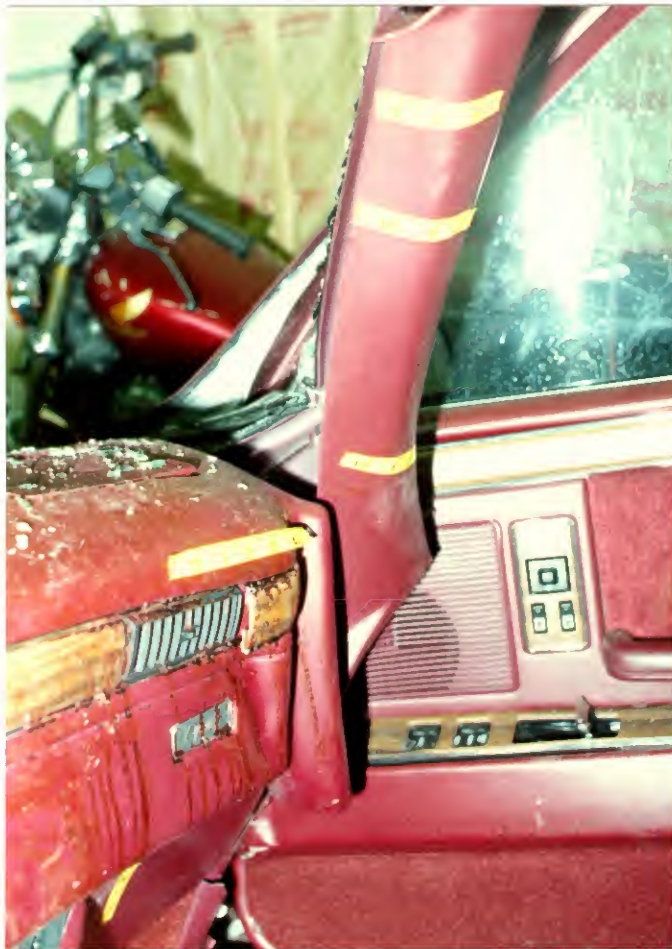
Passenger Head And Face  
Contacts To The Right  
A-Pillar and Windshield

<u>Injury</u>	<u>Severity (OIC/AIS)</u>	<u>Source</u>
Closed head injury with prolonged loss of consciousness, unresponsive to pain stimuli	Critical (HWKB-5)	Right upper A-pillar
Basilar skull fracture	Serious (HIFS-3)	Right upper A-pillar
Multiple facial lacerations and abrasions	Minor (FWLI-1, FWAI-1)	Windshield
Large contusion of the right forehead	Minor (FSCI-1)	Right upper A-pillar

Basilar skull fracture  
(AIS-3), upper right  
A-pillar contact

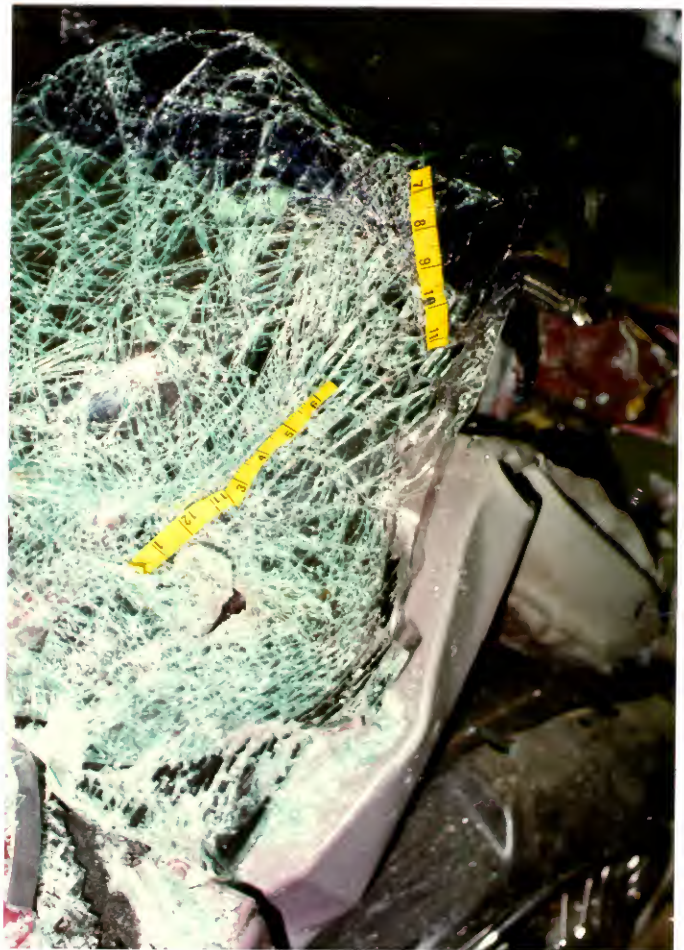
Interior (Air Bag Vehicle) (Cont'd.): of center and involved a 6.5" diameter area of depression with a maximum depth of .75". The passenger's head and face struck the right A-pillar (scuff mark) and windshield. Hair and tissue deposits were noted to the windshield 2.5 - 4" inboard of the pillar and 5 - 17" below the windshield header. There was also a U-shaped tear of the plastic laminate at the lower portion of the tissue deposit.

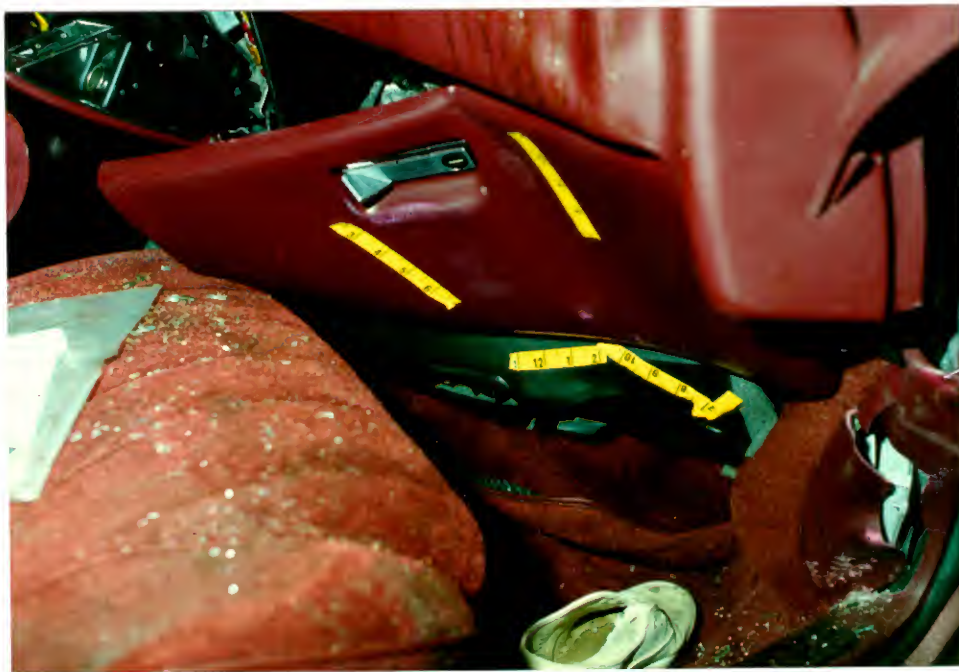
Passenger Knee Contacts To The Glove Box Door

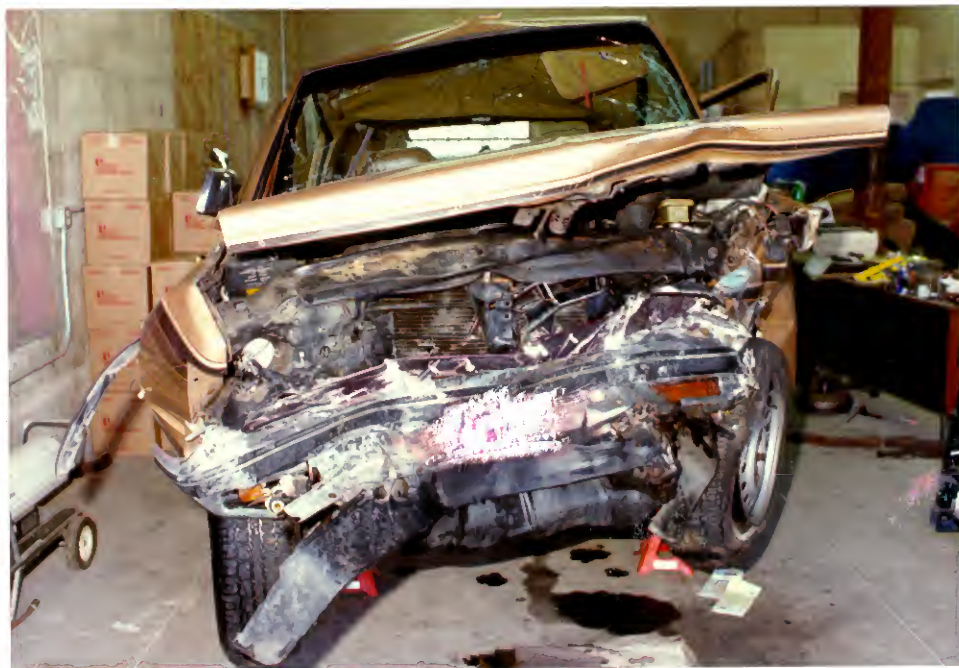
The S-10 Blazer sustained 35.25" of crush located at the left corner of the front bumper. The Blazer's crush profile at bumper level was as follows:  $C_1=35.25"$ ,  $C_2=33.0"$ ,  $C_3=26.6"$ ,  $C_4=19.75"$ ,  $C_5=15.5"$ ,  $C_6=13.6"$ . The damage mode of the CRASHPC program computed velocity changes of 41.7 mph for the Dynasty and 40.7 mph for the S-10 Blazer. As a result of the impact induced deceleration, the Dynasty's driver air bag system deployed.

Frontal View Of Vehicle #2

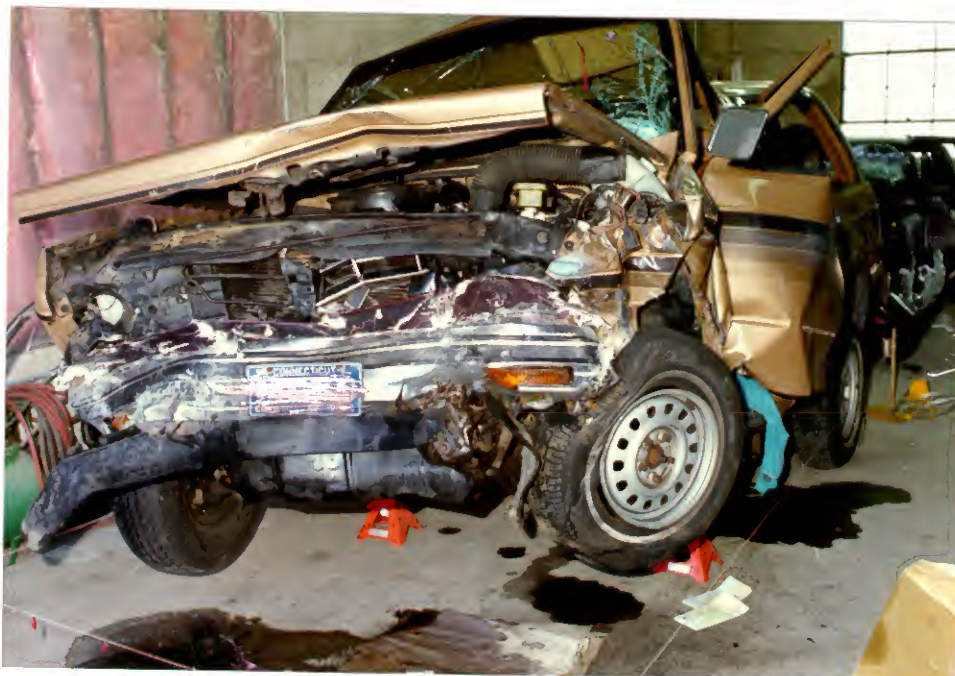
Left Front Three-Quarter View

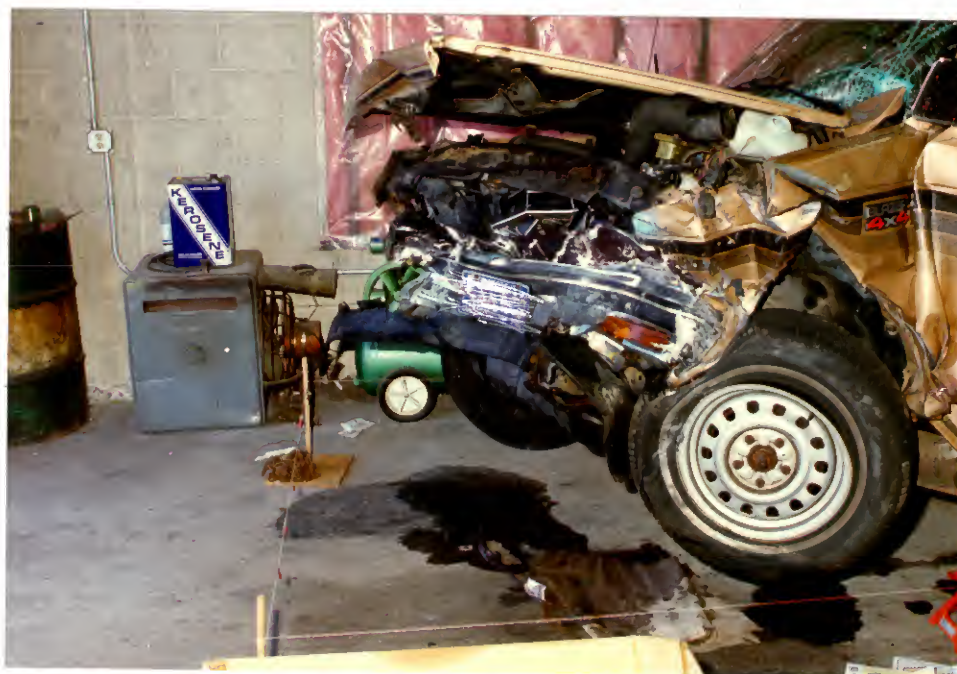
Perpendicular View Of The Left Front Corner Showing The Extent of Crush

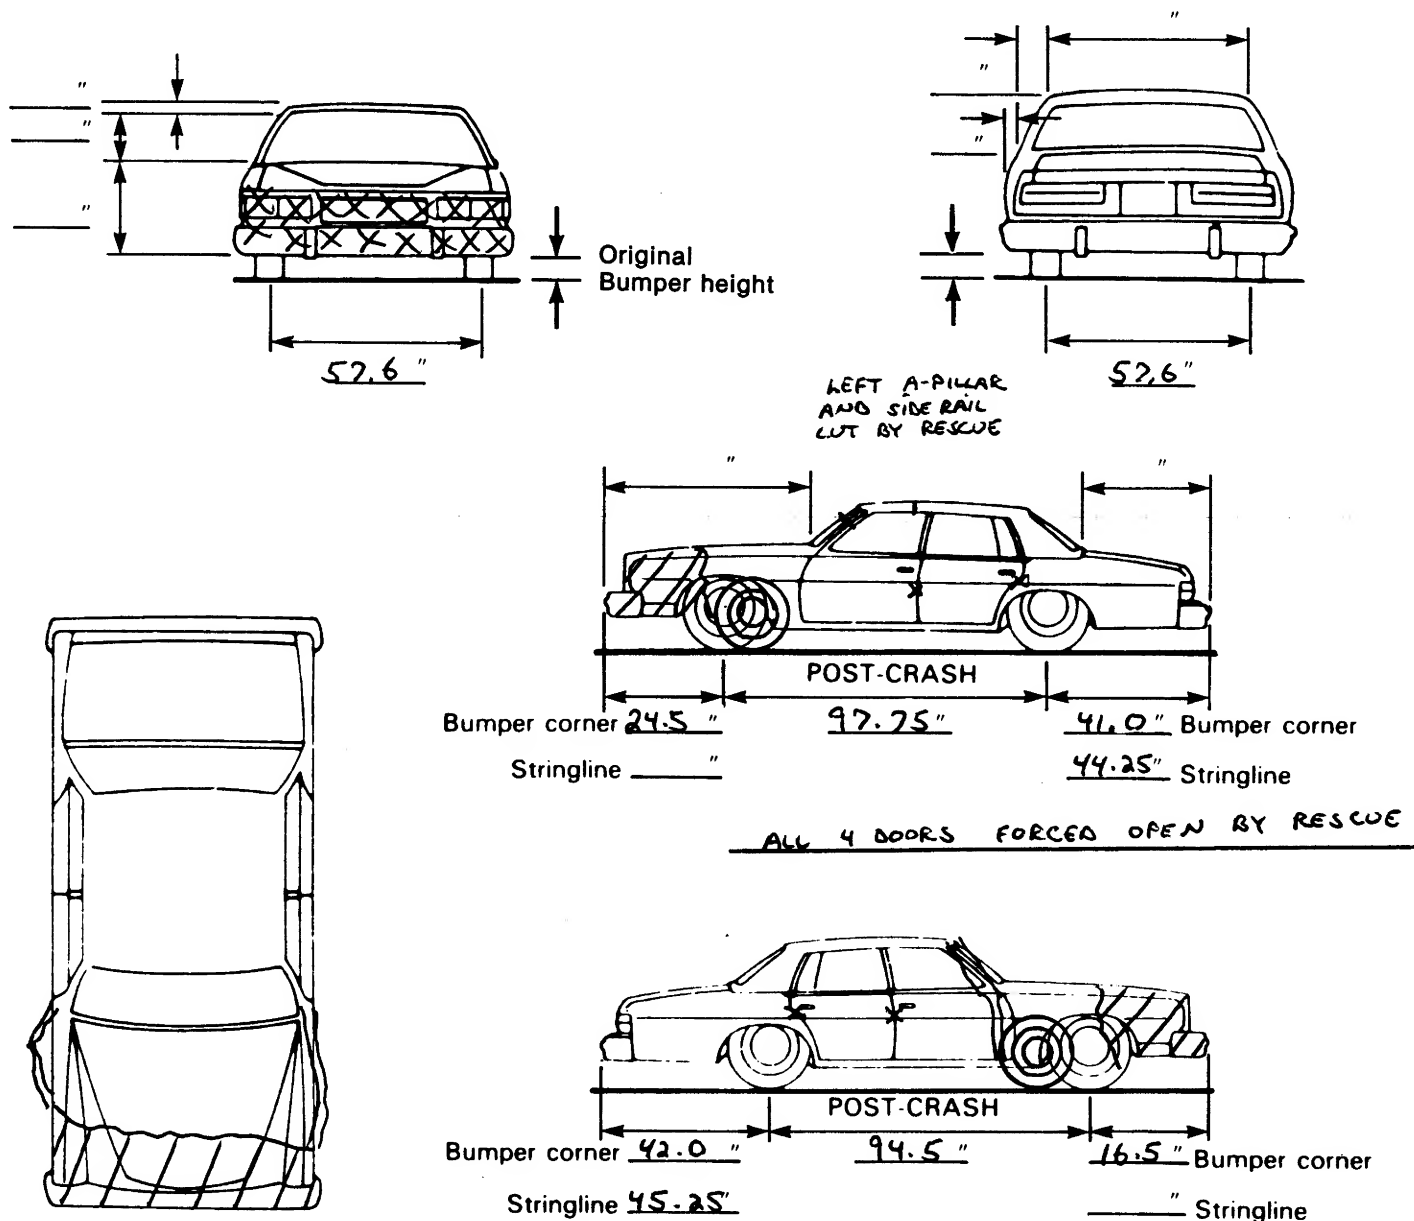
## VEHICLE DAMAGE SKETCH

Specific Impact No.	Location of Direct Damage	Location of Field L	Location of Maximum Crush
1	FRONT BUMPER 53.5"	FRONT BUMPER 53.5"	ON BUMPER, 13.5" RIGHT OF CENTER

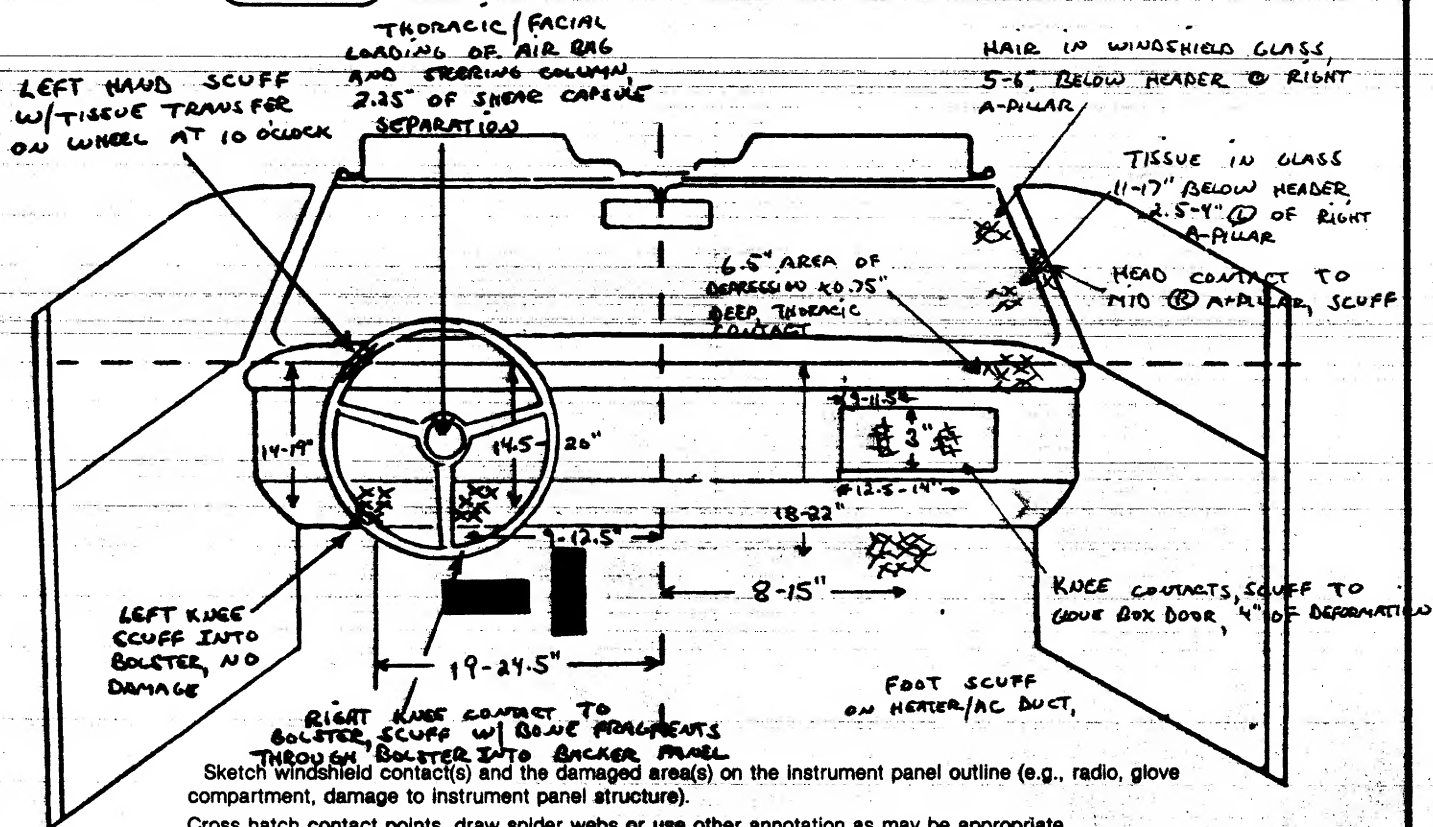
## VEHICLE INTERIOR SKETCHES

Contact	Interior Component Contacted	Occupant No. If Known	Body Region If Known	Supporting Physical Evidence	Confidence Level of Contact Point
A	45	1	FACE/TORSO	TRAJECTORY	1
B	13	1	① KNEE	SCUFF	1
C	13	1	② KNEE	BONE FRAGMENTS	1
D	04	1	TORSO	2.5" SHEAR COMPRESSION	1
E	04	1	① HAND	SCUFF/TISSUE TRANSFER	1
F	12	2	KNEES	SCUFFED, DEFORMED	1
G	11	2	TORSO	1.75" x 6.5" DEPRESSION	1
H	32	2	HEAD	SCUFF	1
I	01	2	FACE	HAIR/TISSUE	1
J					
K					
L					
M					
N
